Safety Bulletin

FIRE-LITE ALARMS
by Honeywell

MS-5012 Limited Product Replacement

August 1, 2007
Document FLSB07-08-01

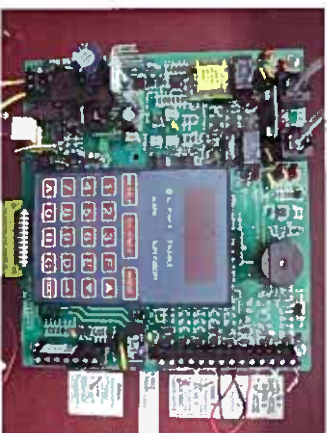
Looking at board enclosed
in the back-box.

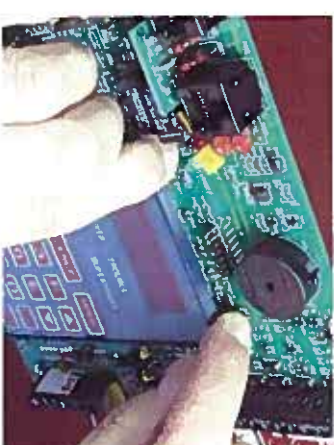
Remove bezel by pushing down
on top legs to release bezel from
the board.

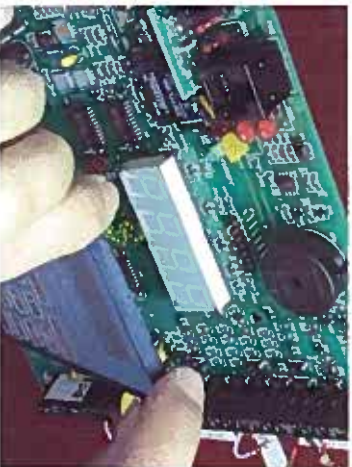
Let bezel fall forward. Do not pull.
Bottom legs are still in board and
can break off.

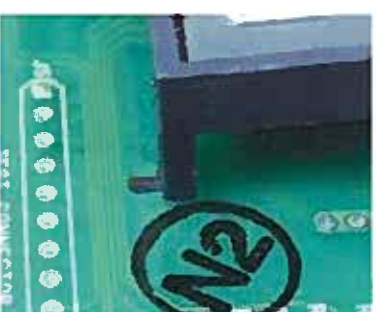
Legs must be pushed up to the
top of the opening then lifted out.

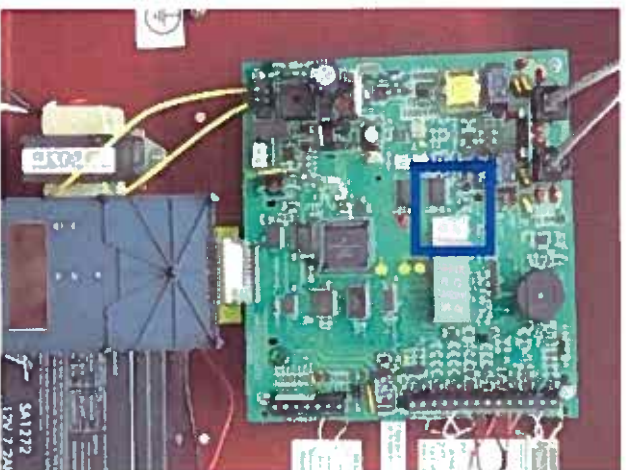
Lift bezel back to expose the parts affixed to the board.
